Category: Accessory Products

Document Number: 5012614A

Description: **Jeep JK Front Corner Separation / Repair**

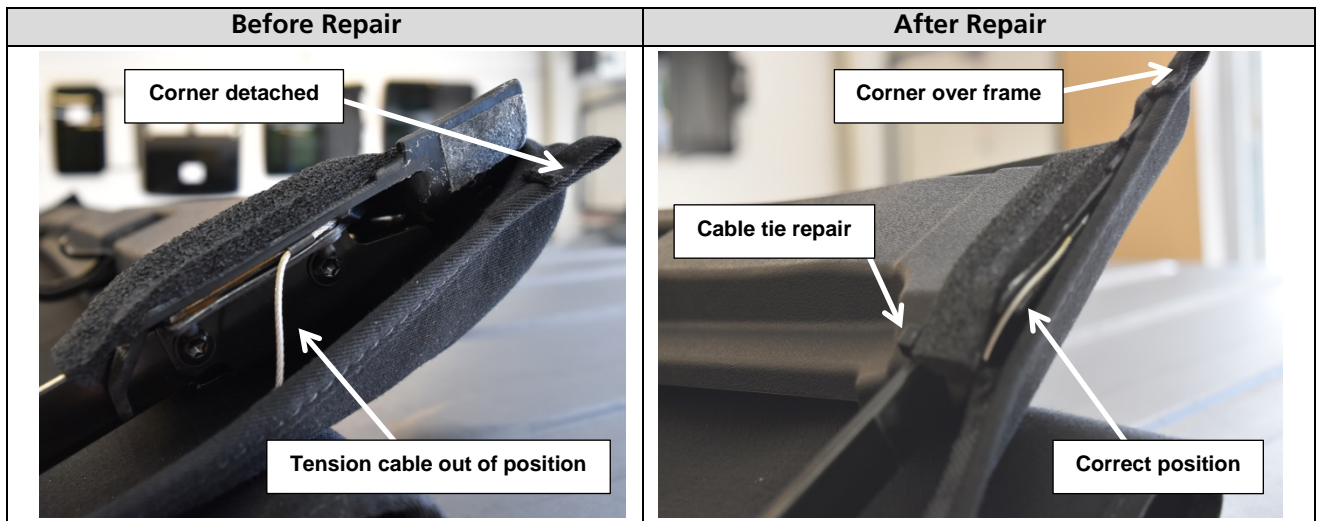
In certain conditions with the ThrowBack Top in the open position it is possible for the left and / or right canvas corners to release from the frame as shown below. This is strictly a cosmetic issue and there is no possibility of further canvas separation.

This modification will ensure that the canvas tension cables that run through each side of the ThrowBack Top maintain proper tension while in the full open position. Follow the instructions below for proper installation.

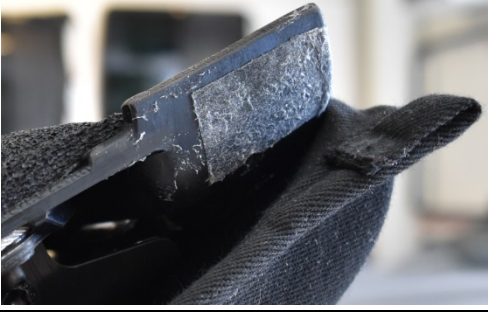
2.

If either corner has separated from the frame, re-install them at this time. There is no need to replace the two sided tape on frame corners as warm ambient temperature will re-adhere this tape.
3.

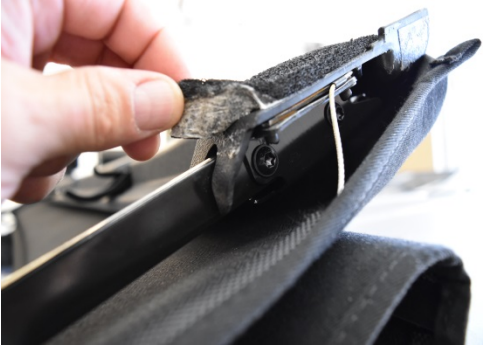
For this installation the driver's side mechanism will be used as reference. Locate the foam strip installed along the side rail. From the rear most end of the foam, carefully peel back 1 inch to access this location for the following steps.
4.

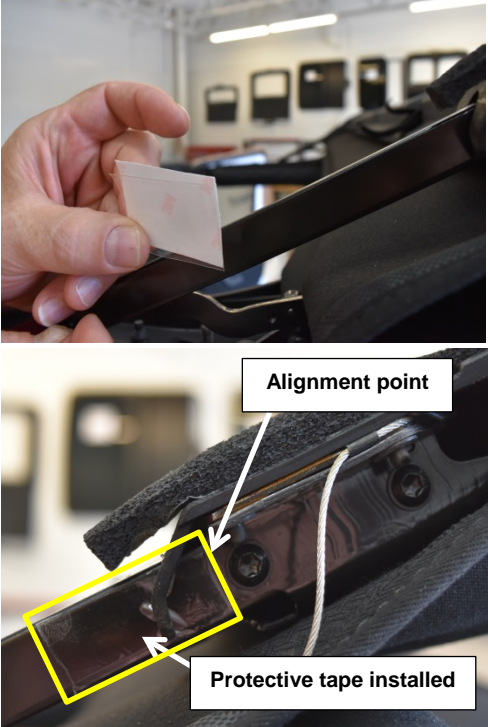
<p>Alignment point</p> <p>Protective tape installed</p>	Remove backing from the supplied protective tape. Begin aligning the protective tape around underside of mechanism rail. Install protective tape as shown beginning by aligning to the edge of the header beam as shown. This will prevent any possibility of a rubbing effect from the soon to be installed cable tie.
